## Analysis of the cavitation phenomenon: A case study in the drainage channel of the Aruana neighborhood located in the city of Aracaju-SE

After the on-site inspection, which took place on 14/07/2021, a visual survey of the occurrences of cavitation wear was carried out, with images recorded, in order to assess the condition of the structure.

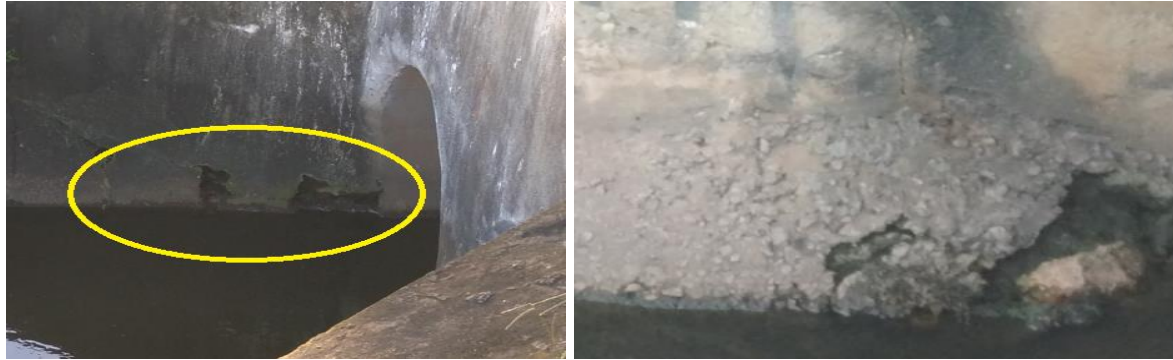
**FIGURE 04:** Erosion and cavitation wear at points near the culverts.

An analysis of Figure 04 shows that the outlet areas of culverts are susceptible to this type of occurrence, as they create pressure differences due to the change in water flow, which favor the appearance of bubbles, and causing cavitation damage. The pathological effects of cavitation on drainage structures always occur downstream from the source that caused it (Aguiar; Batista, 2011).

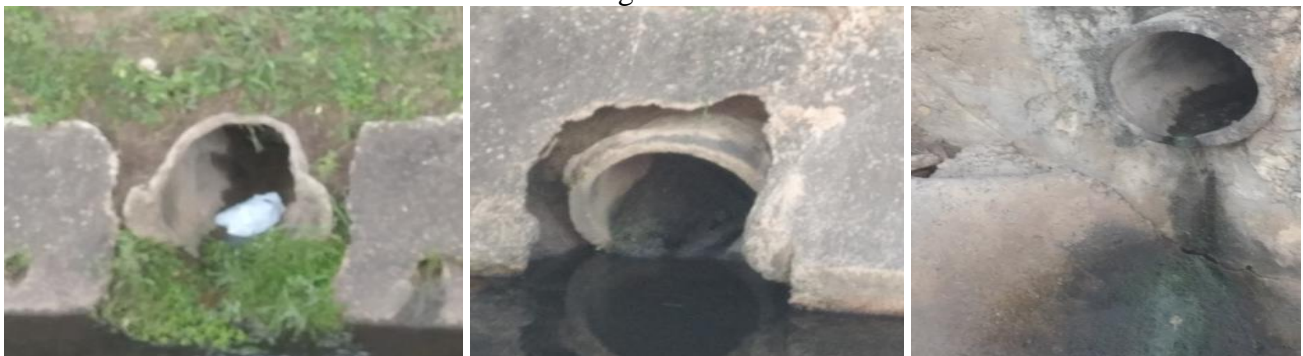
**FIGURE 05:** Erosion and cavitation wear at the connection between the rainwater galleries and the urban drainage channel.

It's observed in figure 05 that the points where the rainwater galleries connect to the canal can be considered critical points for the occurrence of erosion and cavitation. These points are characterized by a sudden change in the speed and direction of the flow, which Andrade (1992) cites as causing cavitation.

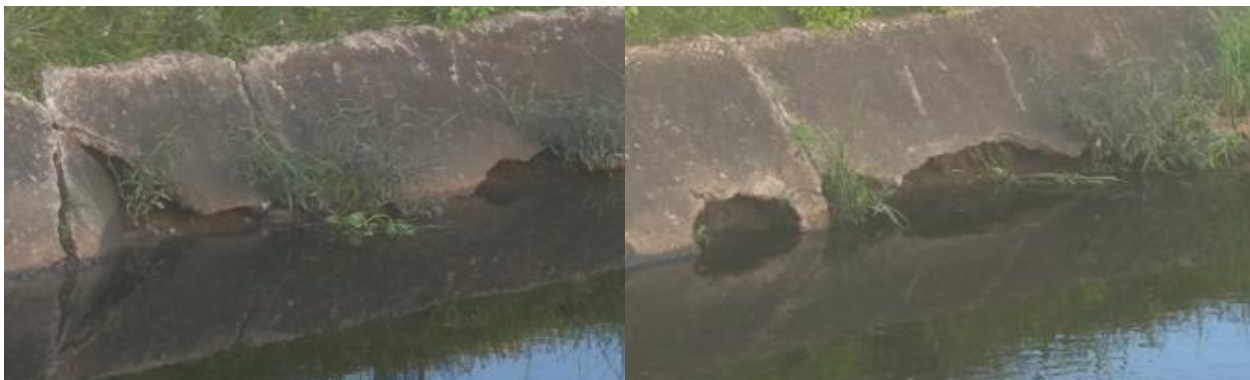
**FIGURE 6:** Erosion and cavitation wear on the side walls of the channel.

Figure 06 shows sections with severe erosion and cavitation on the side walls of the channel caused by the flow of water. This action of the water, together with other occurrences, such as erosion of the soil that serves as the base for the concrete slab, has led to this structure breaking down in some stretches. According to Guabiroba (2012), one pathology is usually the gateway to the development of other pathologies; the process feeds back on itself, leading the structure to deteriorate sharply or even collapse.
