Analysis of the micro-drainage infrastructure on an avenue in the city of Aracaju-SE

Sarah Rolemberg da Silva Ramos¹, Carla Suellen Alves Santos², Carlos Gomes da Silva Júnior³ & Zacarias Caetano Vieira⁴

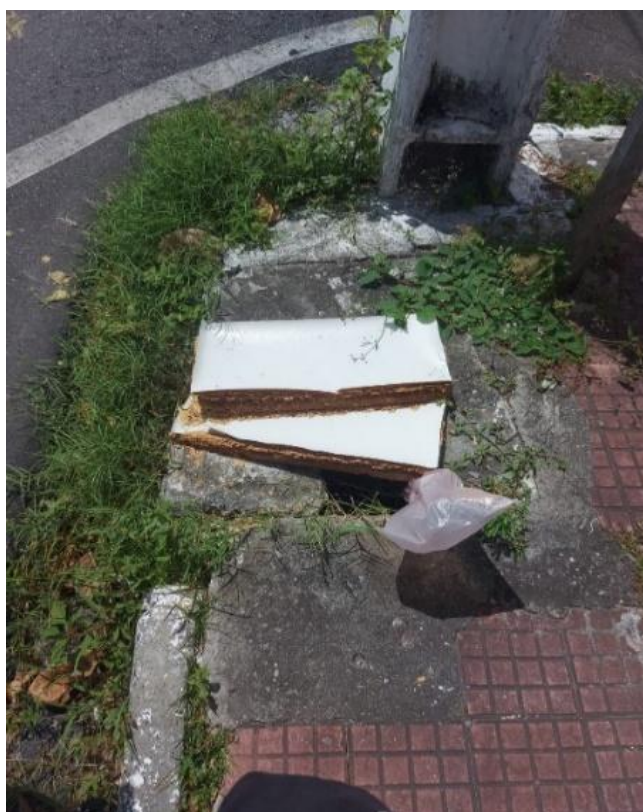
FIGURE 06: Example of poorly located and badly maintained gutter inlets.

As for the state of repair, only 39.5% of gutter inlets are well maintained, while 32.6% are moderately maintained and 27.9% are poorly maintained. This situation is detrimental to the functioning of these devices because, according to Descovi (2022), the state of repair of gutter inlets can indicate a serious maintenance failure, limiting the capacity to swallow rainwater and increasing flooding. Figure 06 below shows a poorly located gutter inlets (corner) in a very poor state of repair.

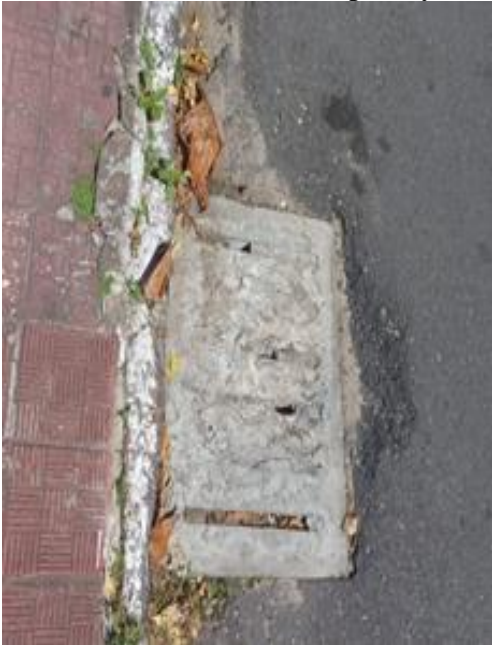
collection coverage, lack of urban cleaning, poor waste disposal by the population and rainfall. Figure 08 shows an example of a completely blocked gutter inlet found during the visit.

FIGURE 08: Gutter inlet completely blocked.

- a) it is extremely necessary to clean the devices more frequently, in order to avoid such high rates of blockage of the gutter inlets.
- b) Raising awareness among the population is essential to maintaining the efficient functioning of the drainage system, because if garbage is thrown onto the streets, it will end up in the urban drainage system if it rains before the variation;
- c) when building drainage networks, care must always be taken to carefully analyze the location of the devices, as this has an impact on their efficiency and durability, as well as interfering with traffic flow.

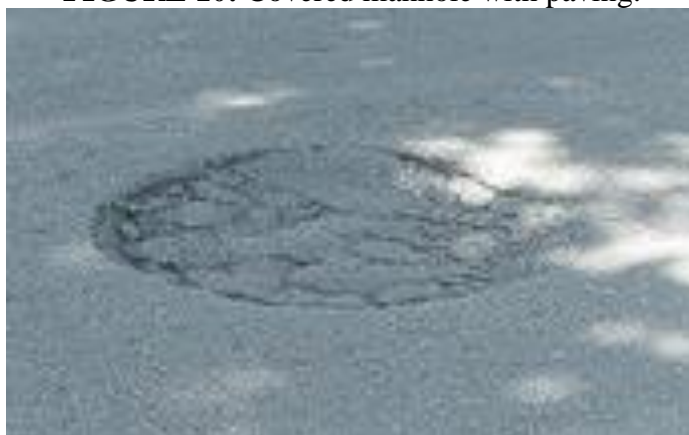
As shown in Figure 09, only 10% of the manholes are properly positioned, i.e. they are located in central areas of the lanes, reducing the passage of car tires over the device. Improperly located manholes are found in the lane of the avenue where car tires pass over them, resulting in damage to these devices and reducing their useful life. There were also manholes covered with paving, as shown in Figure 10 below.

FIGURE 10: Covered manhole with paving.
