Analysis of the micro-drainage infrastructure on an avenue in the city of Aracaju-SE

Sarah Rolemberg da Silva Ramos¹, Carla Suellen Alves Santos², Carlos Gomes da Silva Júnior³ & Zacarias Caetano Vieira⁴

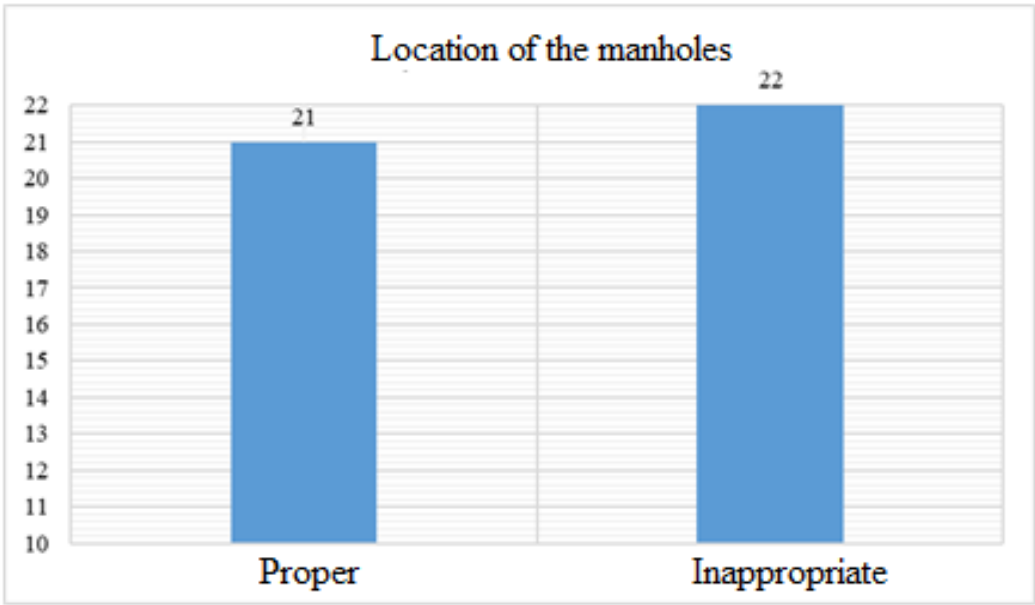
FIGURE 05 (a): Location of the gutter inlets.

According to Figure 05 (a), more than half (51.2%) of the gutter inlets are in an inappropriate location (corners). According to Nakamura (2011), gutter inlets should not be installed on corners (the section with the highest flow rate through the gutter) so that the flow of water does not interfere with the passage of pedestrians, nor does it reduce the efficiency of the device, as the converging torrents through the different gutters would flow at the opposite speed to the inflow into the gutter inlets. For this reason, it is recommended that gutter inlets be installed at points just upstream of each crosswalk used by pedestrians.

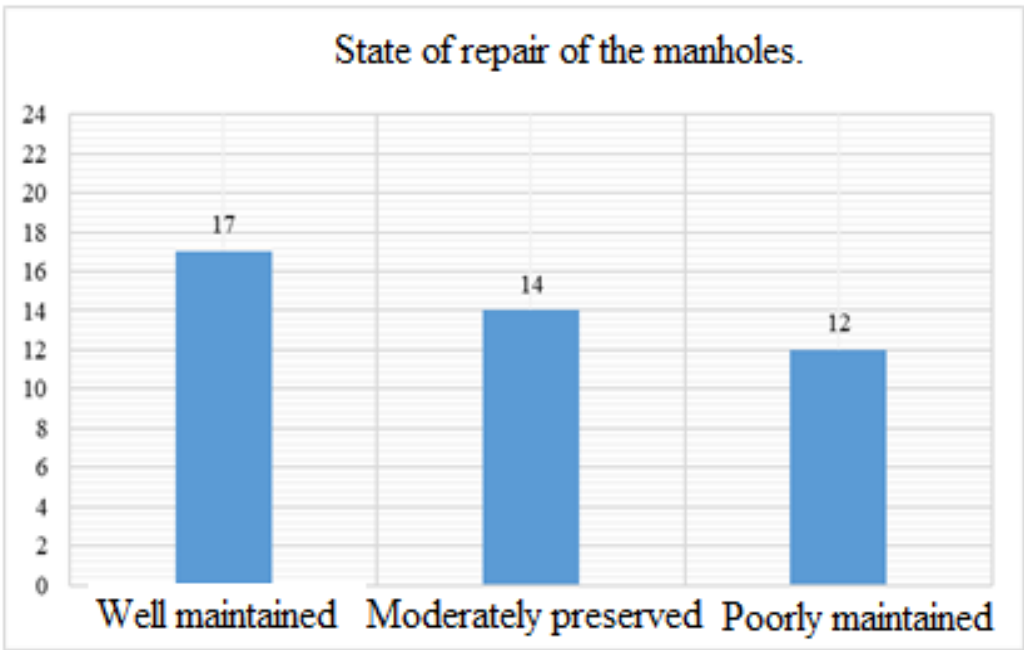
FIGURE 05 (b): State of repair of the gutter inlets

As for the state of repair, only 39.5% of gutter inlets are well maintained, while 32.6% are moderately maintained and 27.9% are poorly maintained. This situation is detrimental to the functioning of these devices because, according to Descovi (2022), the state of repair of gutter inlets can indicate a serious maintenance failure, limiting the capacity to swallow rainwater and increasing flooding. Figure 06 below shows a poorly located gutter inlets (corner) in a very poor state of repair.

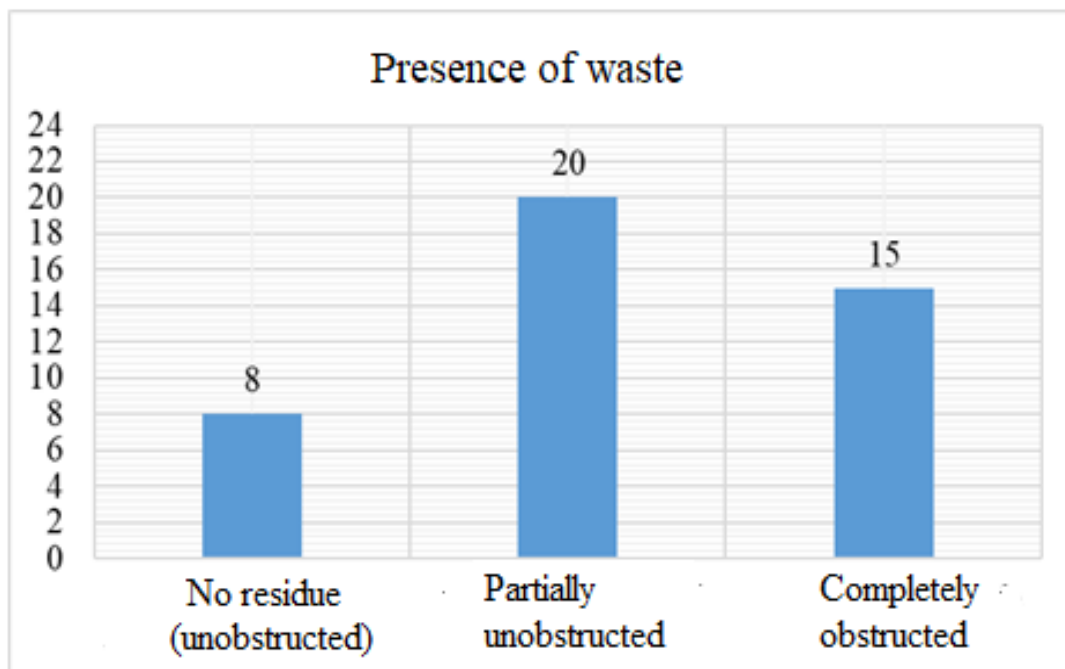
FIGURE 7 (a): Presence of waste in gutter inlets.

With regard to the presence of waste in gutter inlets (Figure 7 a), it can be seen that only 18.6% of the devices evaluated did not have any waste at the time of the inspection, 46.6% were partially blocked and 34.8% were completely blocked. This situation is worrying because, according to Tucci (2005), when solid waste reaches the urban drainage network, most of it accumulates due to inefficient garbage

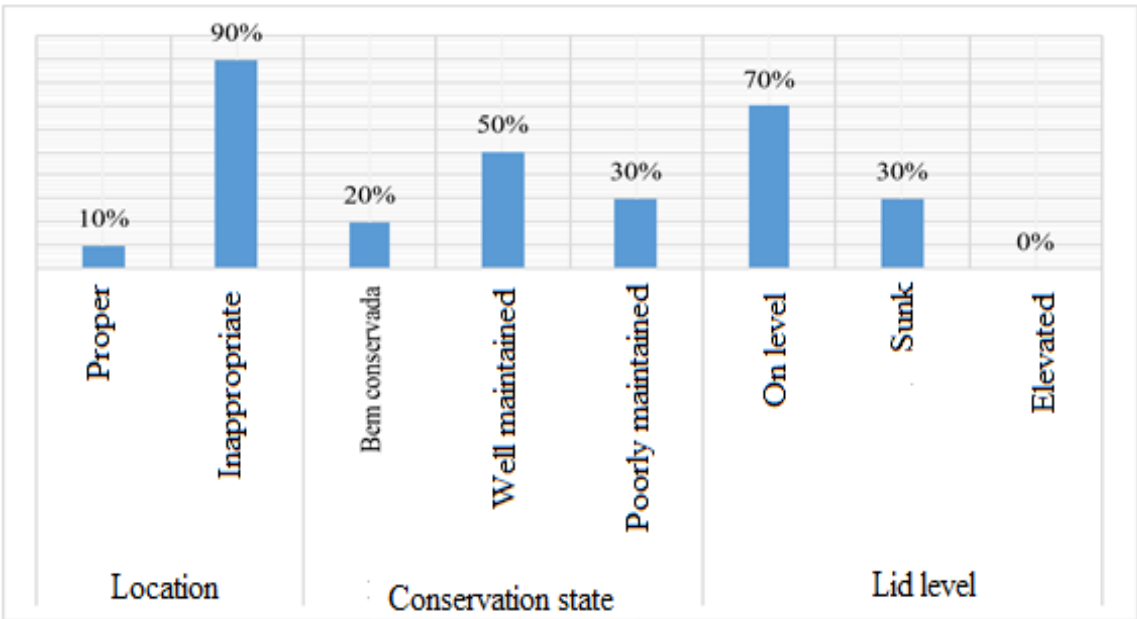
FIGURE 09: Analysis of manholes.

As shown in Figure 09, only 10% of the manholes are properly positioned, i.e. they are located in central areas of the lanes, reducing the passage of car tires over the device. Improperly located manholes are found in the lane of the avenue where car tires pass over them, resulting in damage to these devices and reducing their useful life. There were also manholes covered with paving, as shown in Figure 10 below.

Regarding the state of repair of the manholes, it can be seen that only 20% are well maintained; the other 80% are partially or totally degraded (broken cover, cracks and fissures in the surrounding sidewalk, sinking, among others). As for the leveling of the cover, 70% of the covers are level with the sidewalk, while 30% are sunk, which can cause discomfort for drivers on the avenue. In addition, degraded manholes pose a risk to the population traveling on urban roads.
